STRUCTURE BACKFILL TESTING

FINAL REPORT

RESEARCH REPORT

CADOT-TL-2130-1-73-41

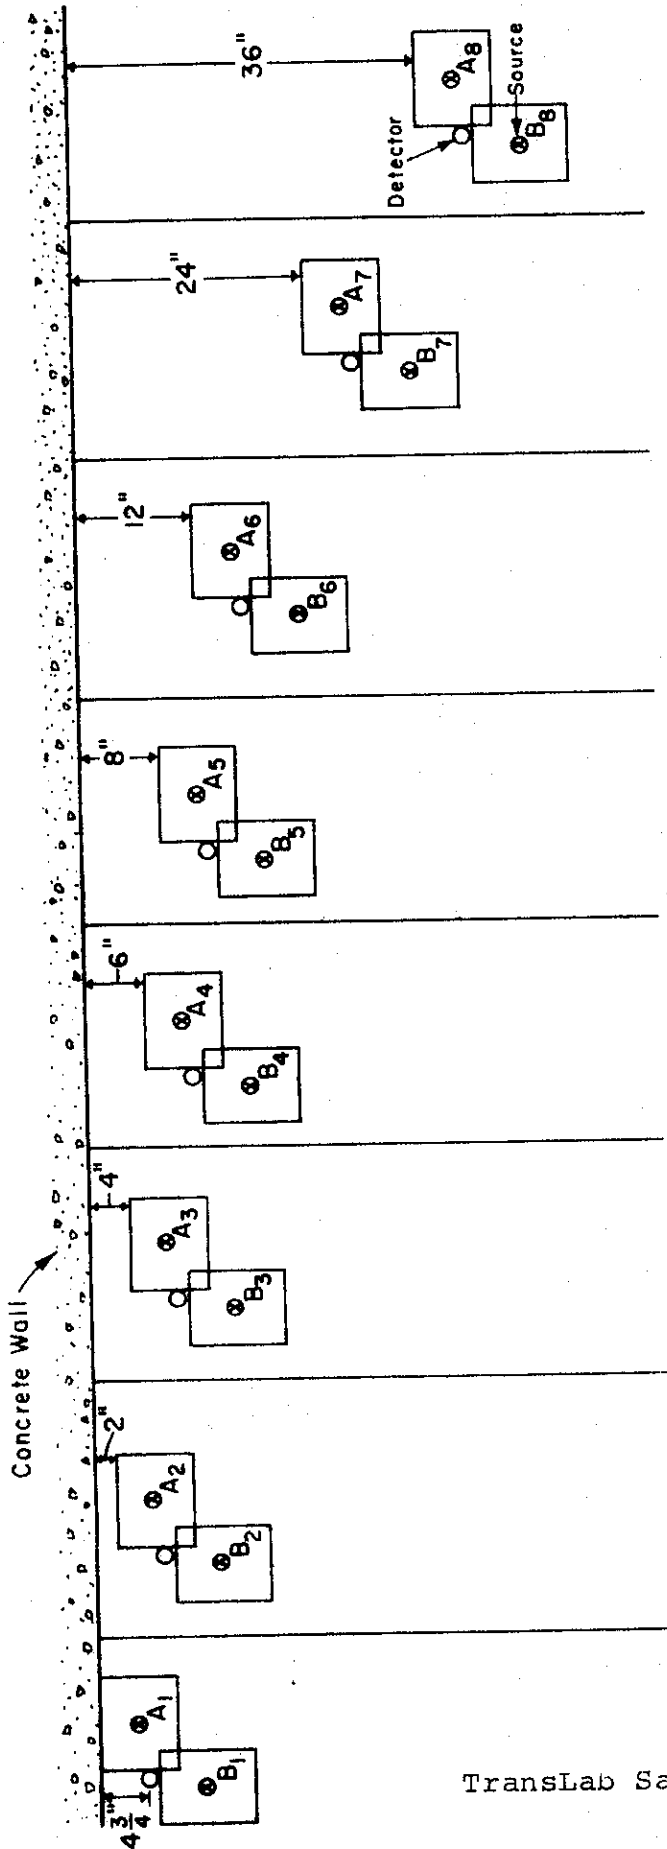
Figure 9

TEST CONFIGURATION ON STRUCTURE BACKFILL NEXT TO A CONCRETE WALL

RTE 5-120 INTERCHANGE IN DISTRICT 10
